Comprehensive Master Plan

First Presbyterian Church *Baton Rouge, Louisiana*

COMPREHENSIVE PLAN

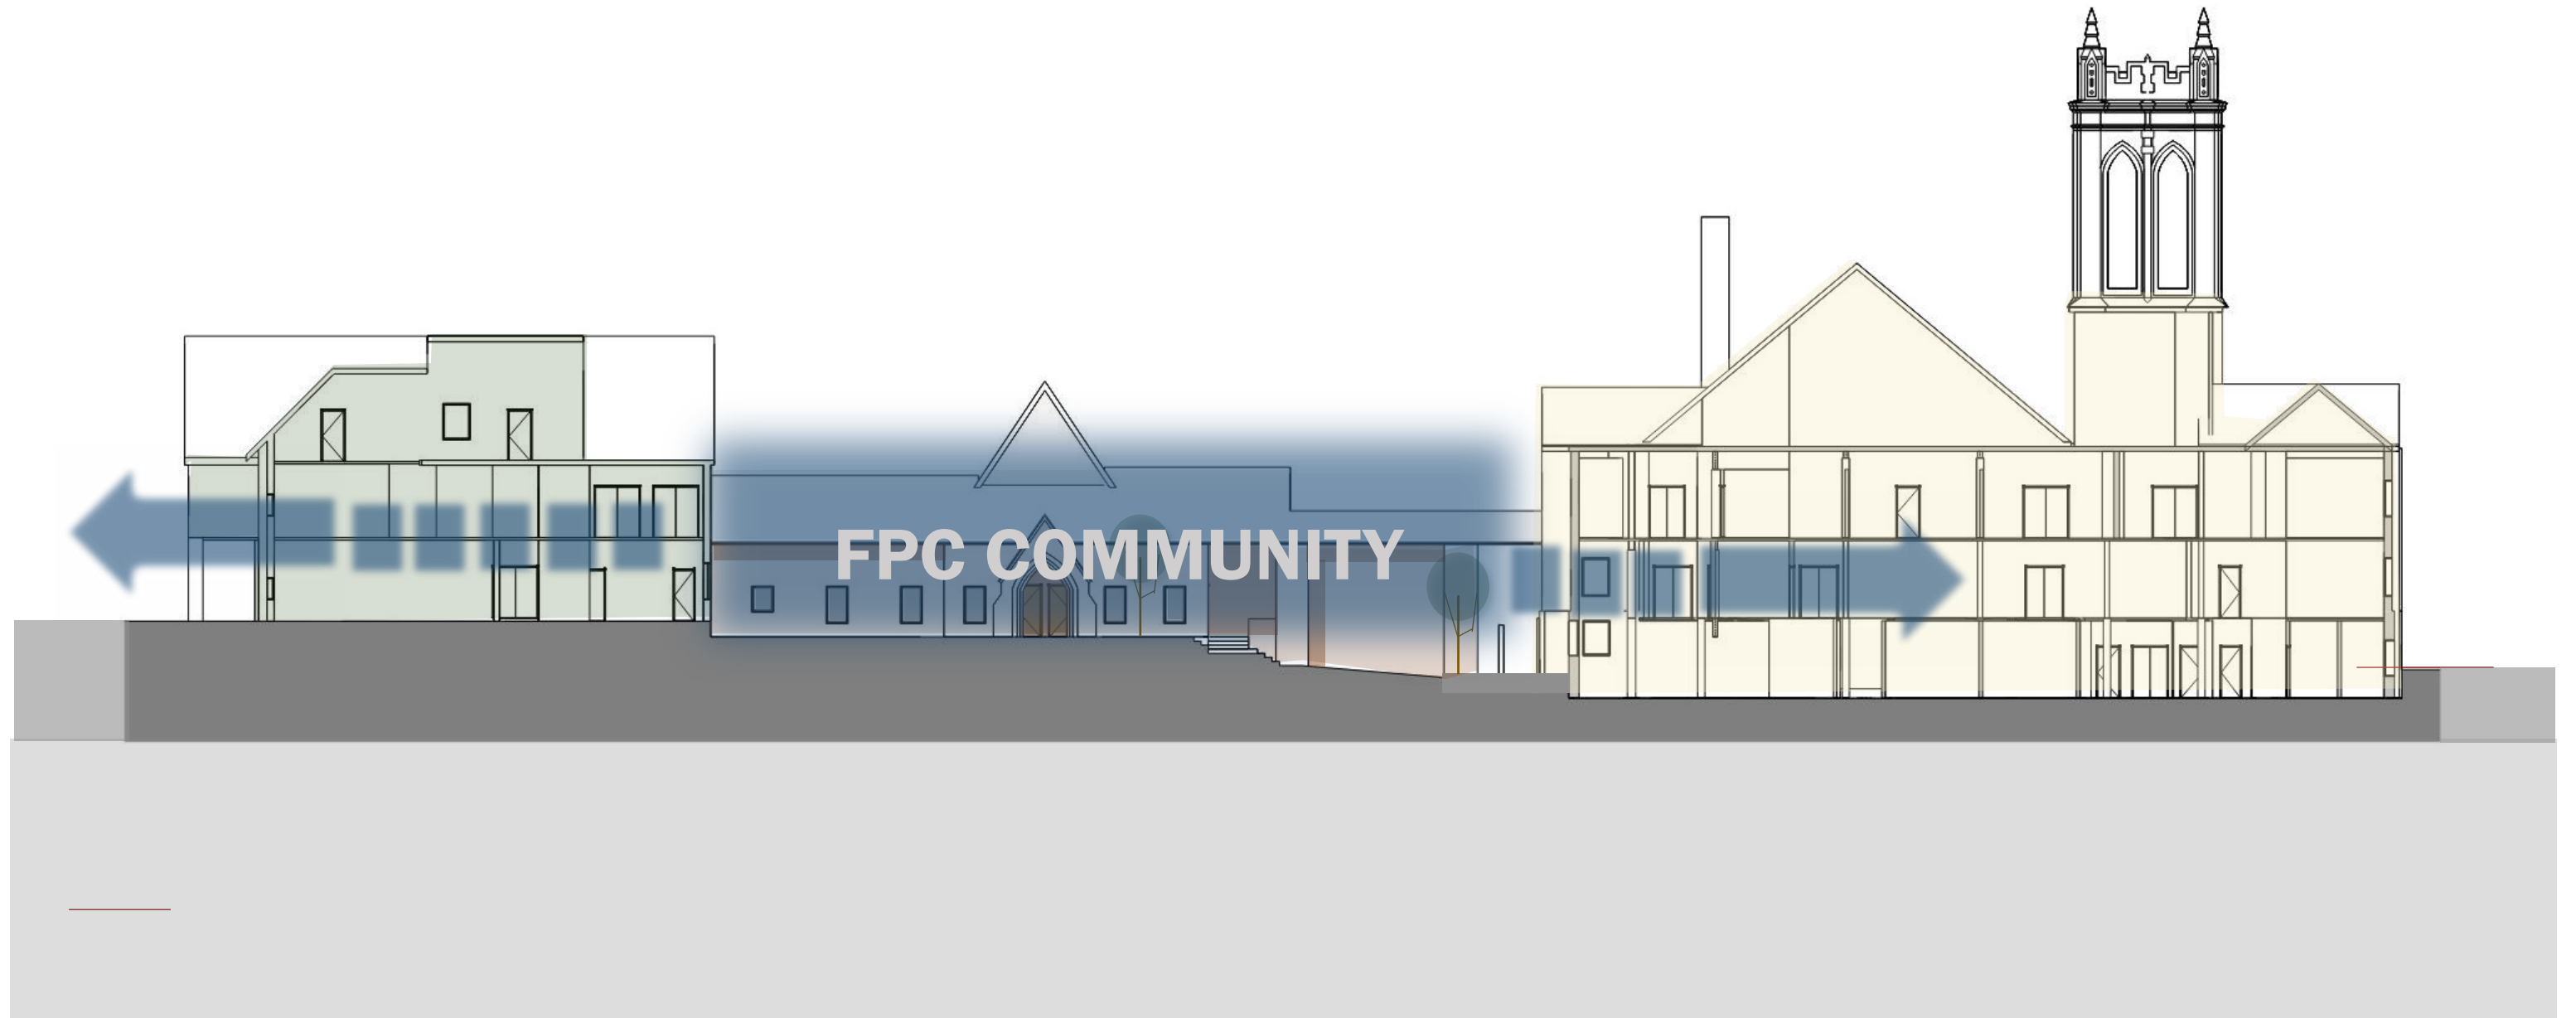
Campus Framework

The existing campus courtyard provides precedent for an active church community core. The master plan framework extends the core by strategically positioning community functions in Sanctuary Building and Education Building for a connected set of community experiences.

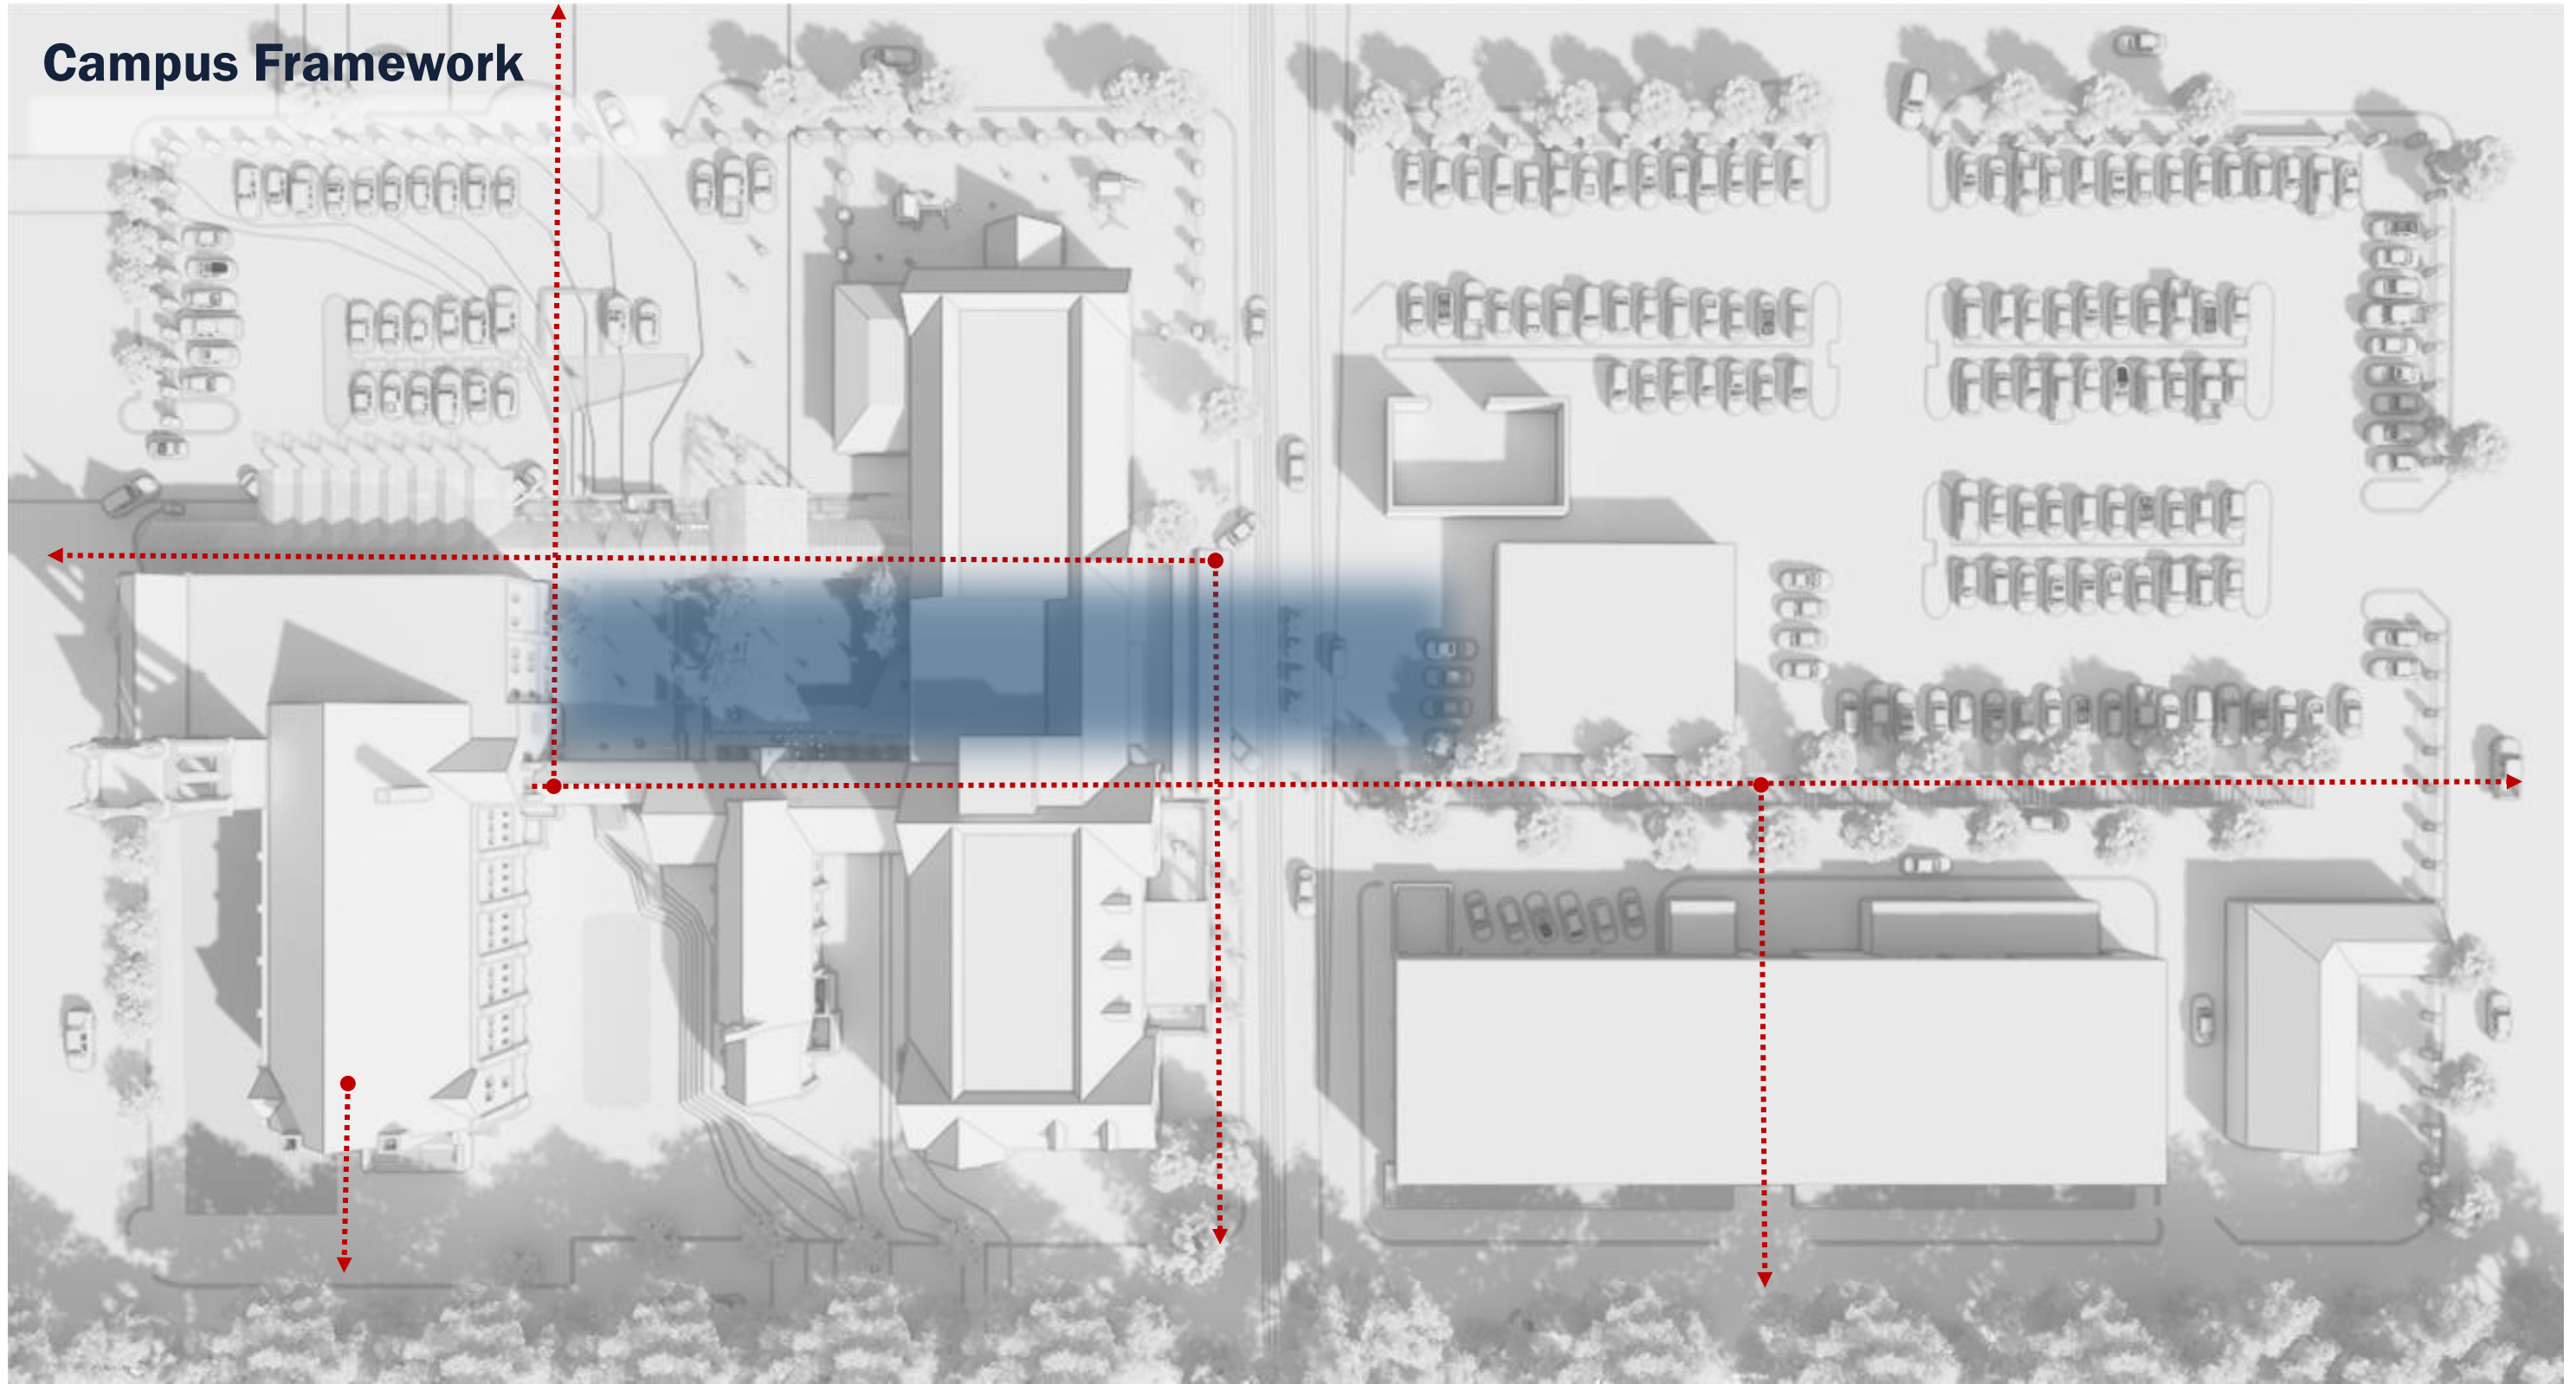
Campus Framework

The expanded campus community core serves as primary organizing device for the master plan.

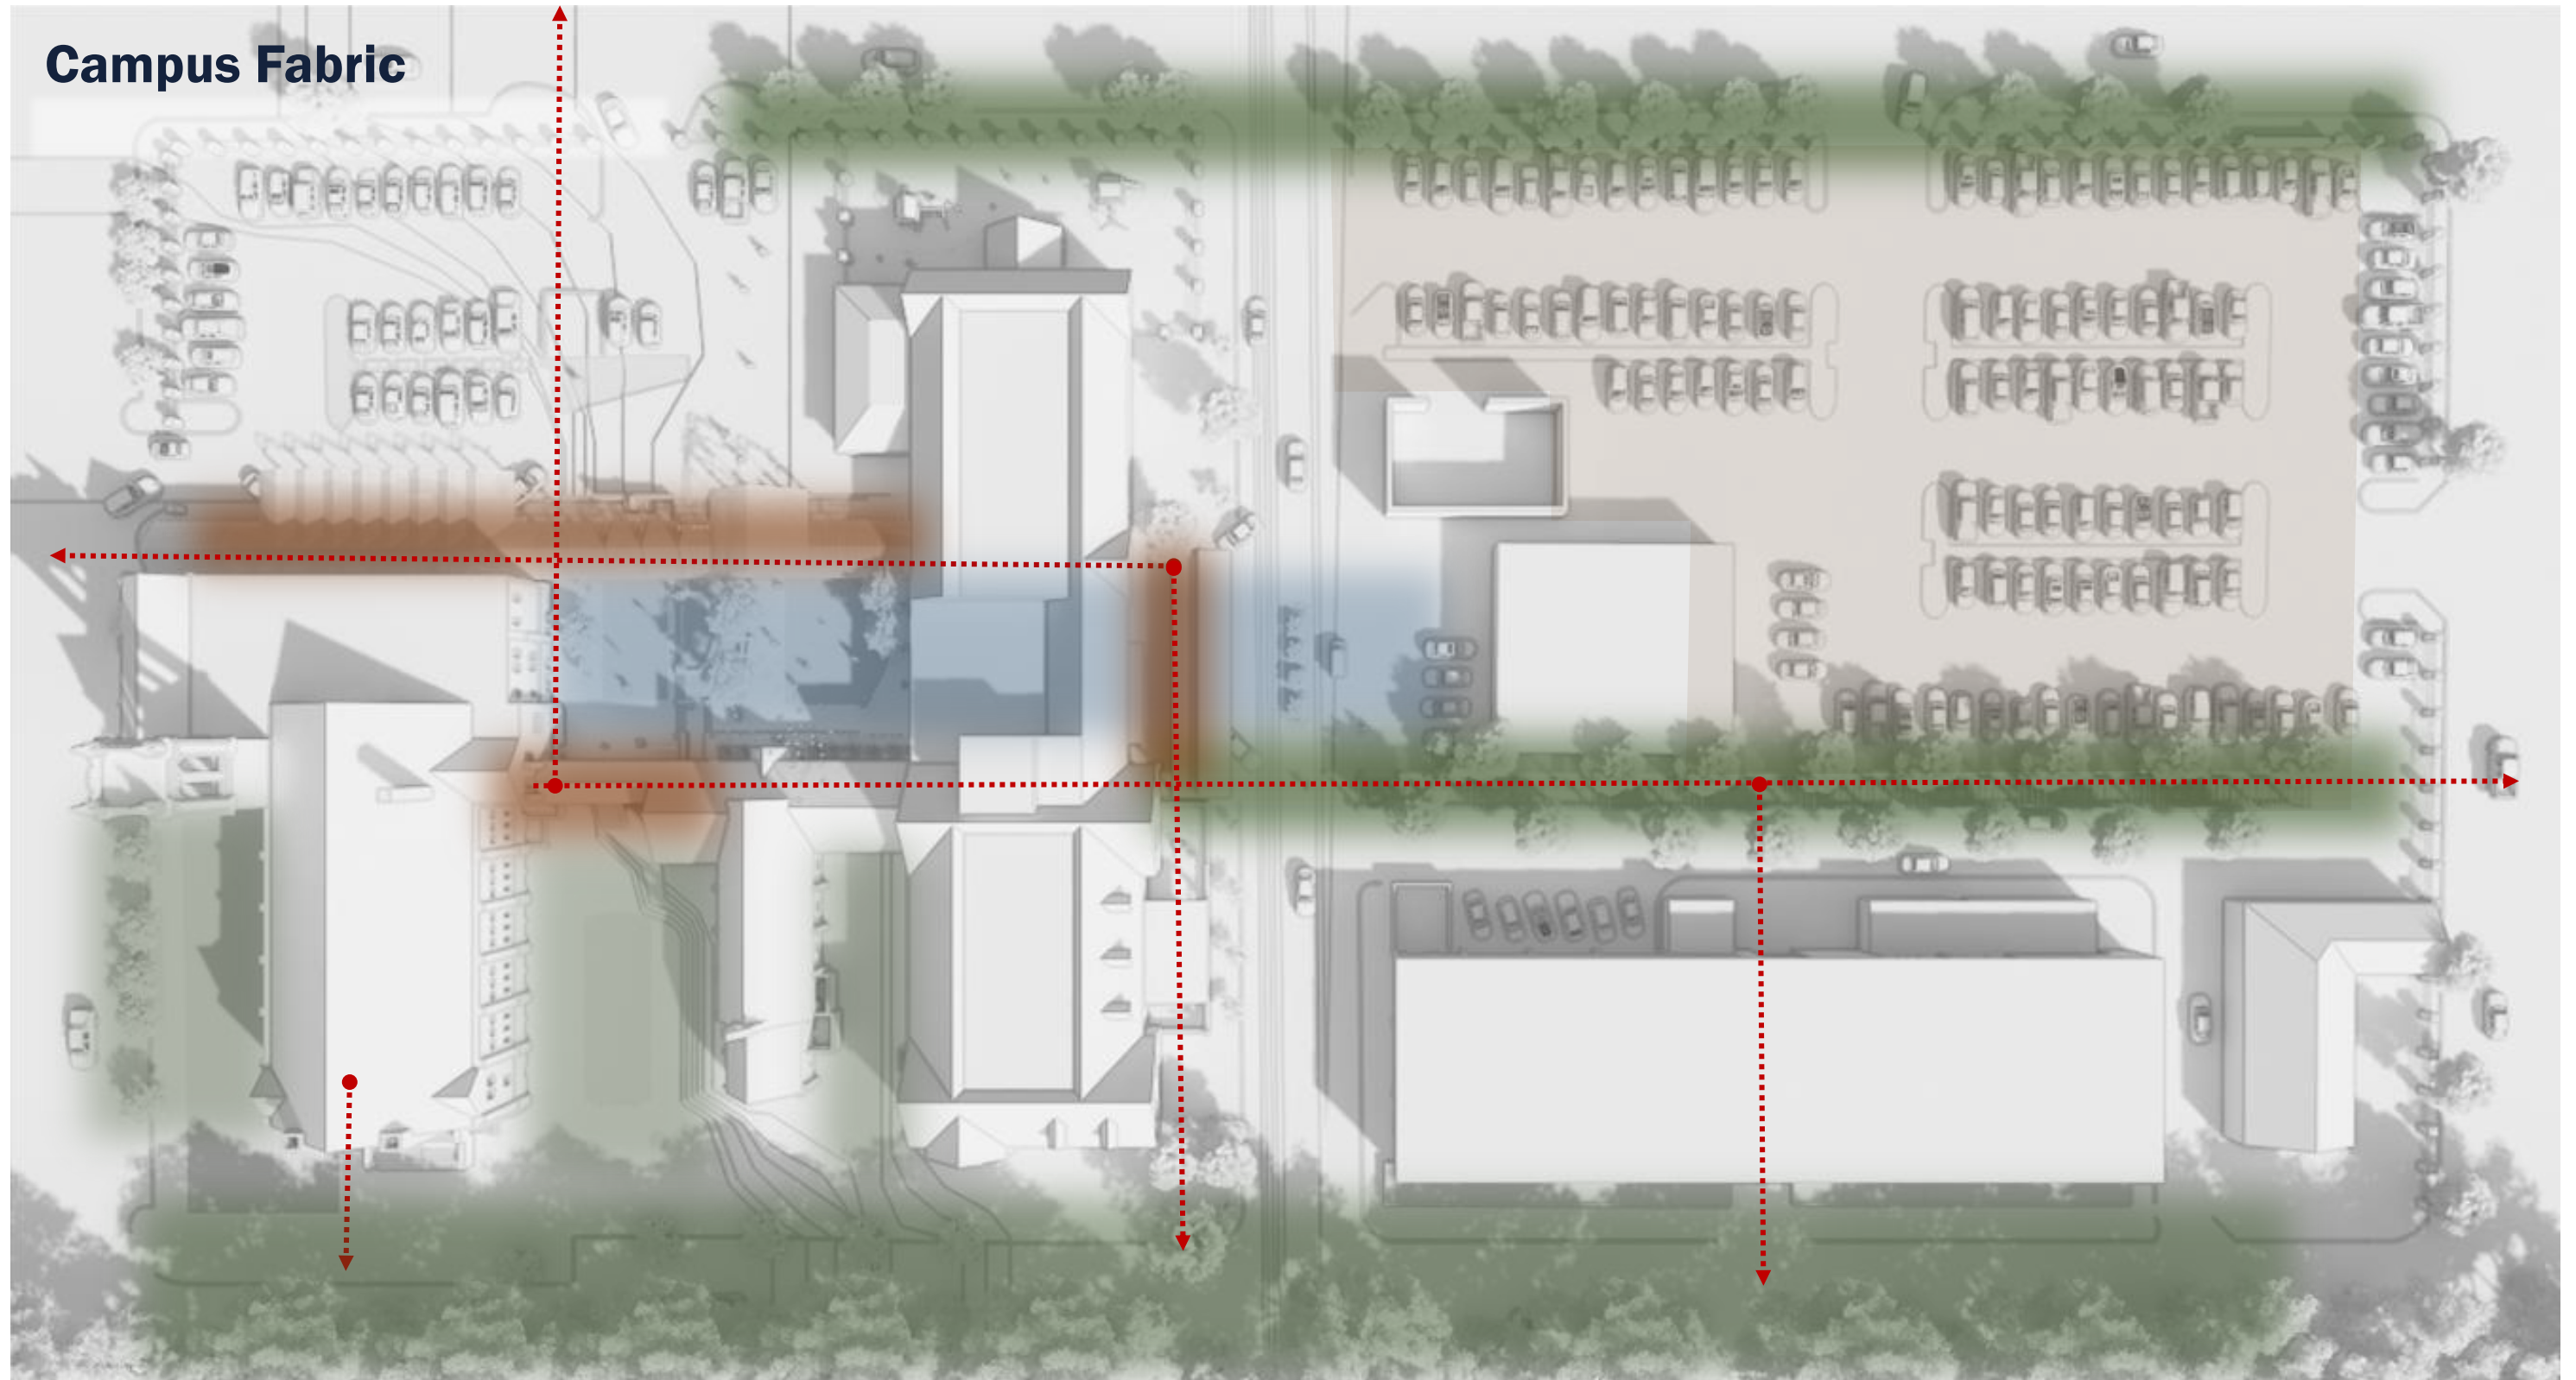
Campus Fabric

The existing and proposed landscape and hardscape development define campus edges and reinforce “Main Street” as a mid-block pedestrian route through campus. Covered walkways and drop-off locations provide reliable connectivity for weekday, Sunday and event circulation irrespective of weather conditions.

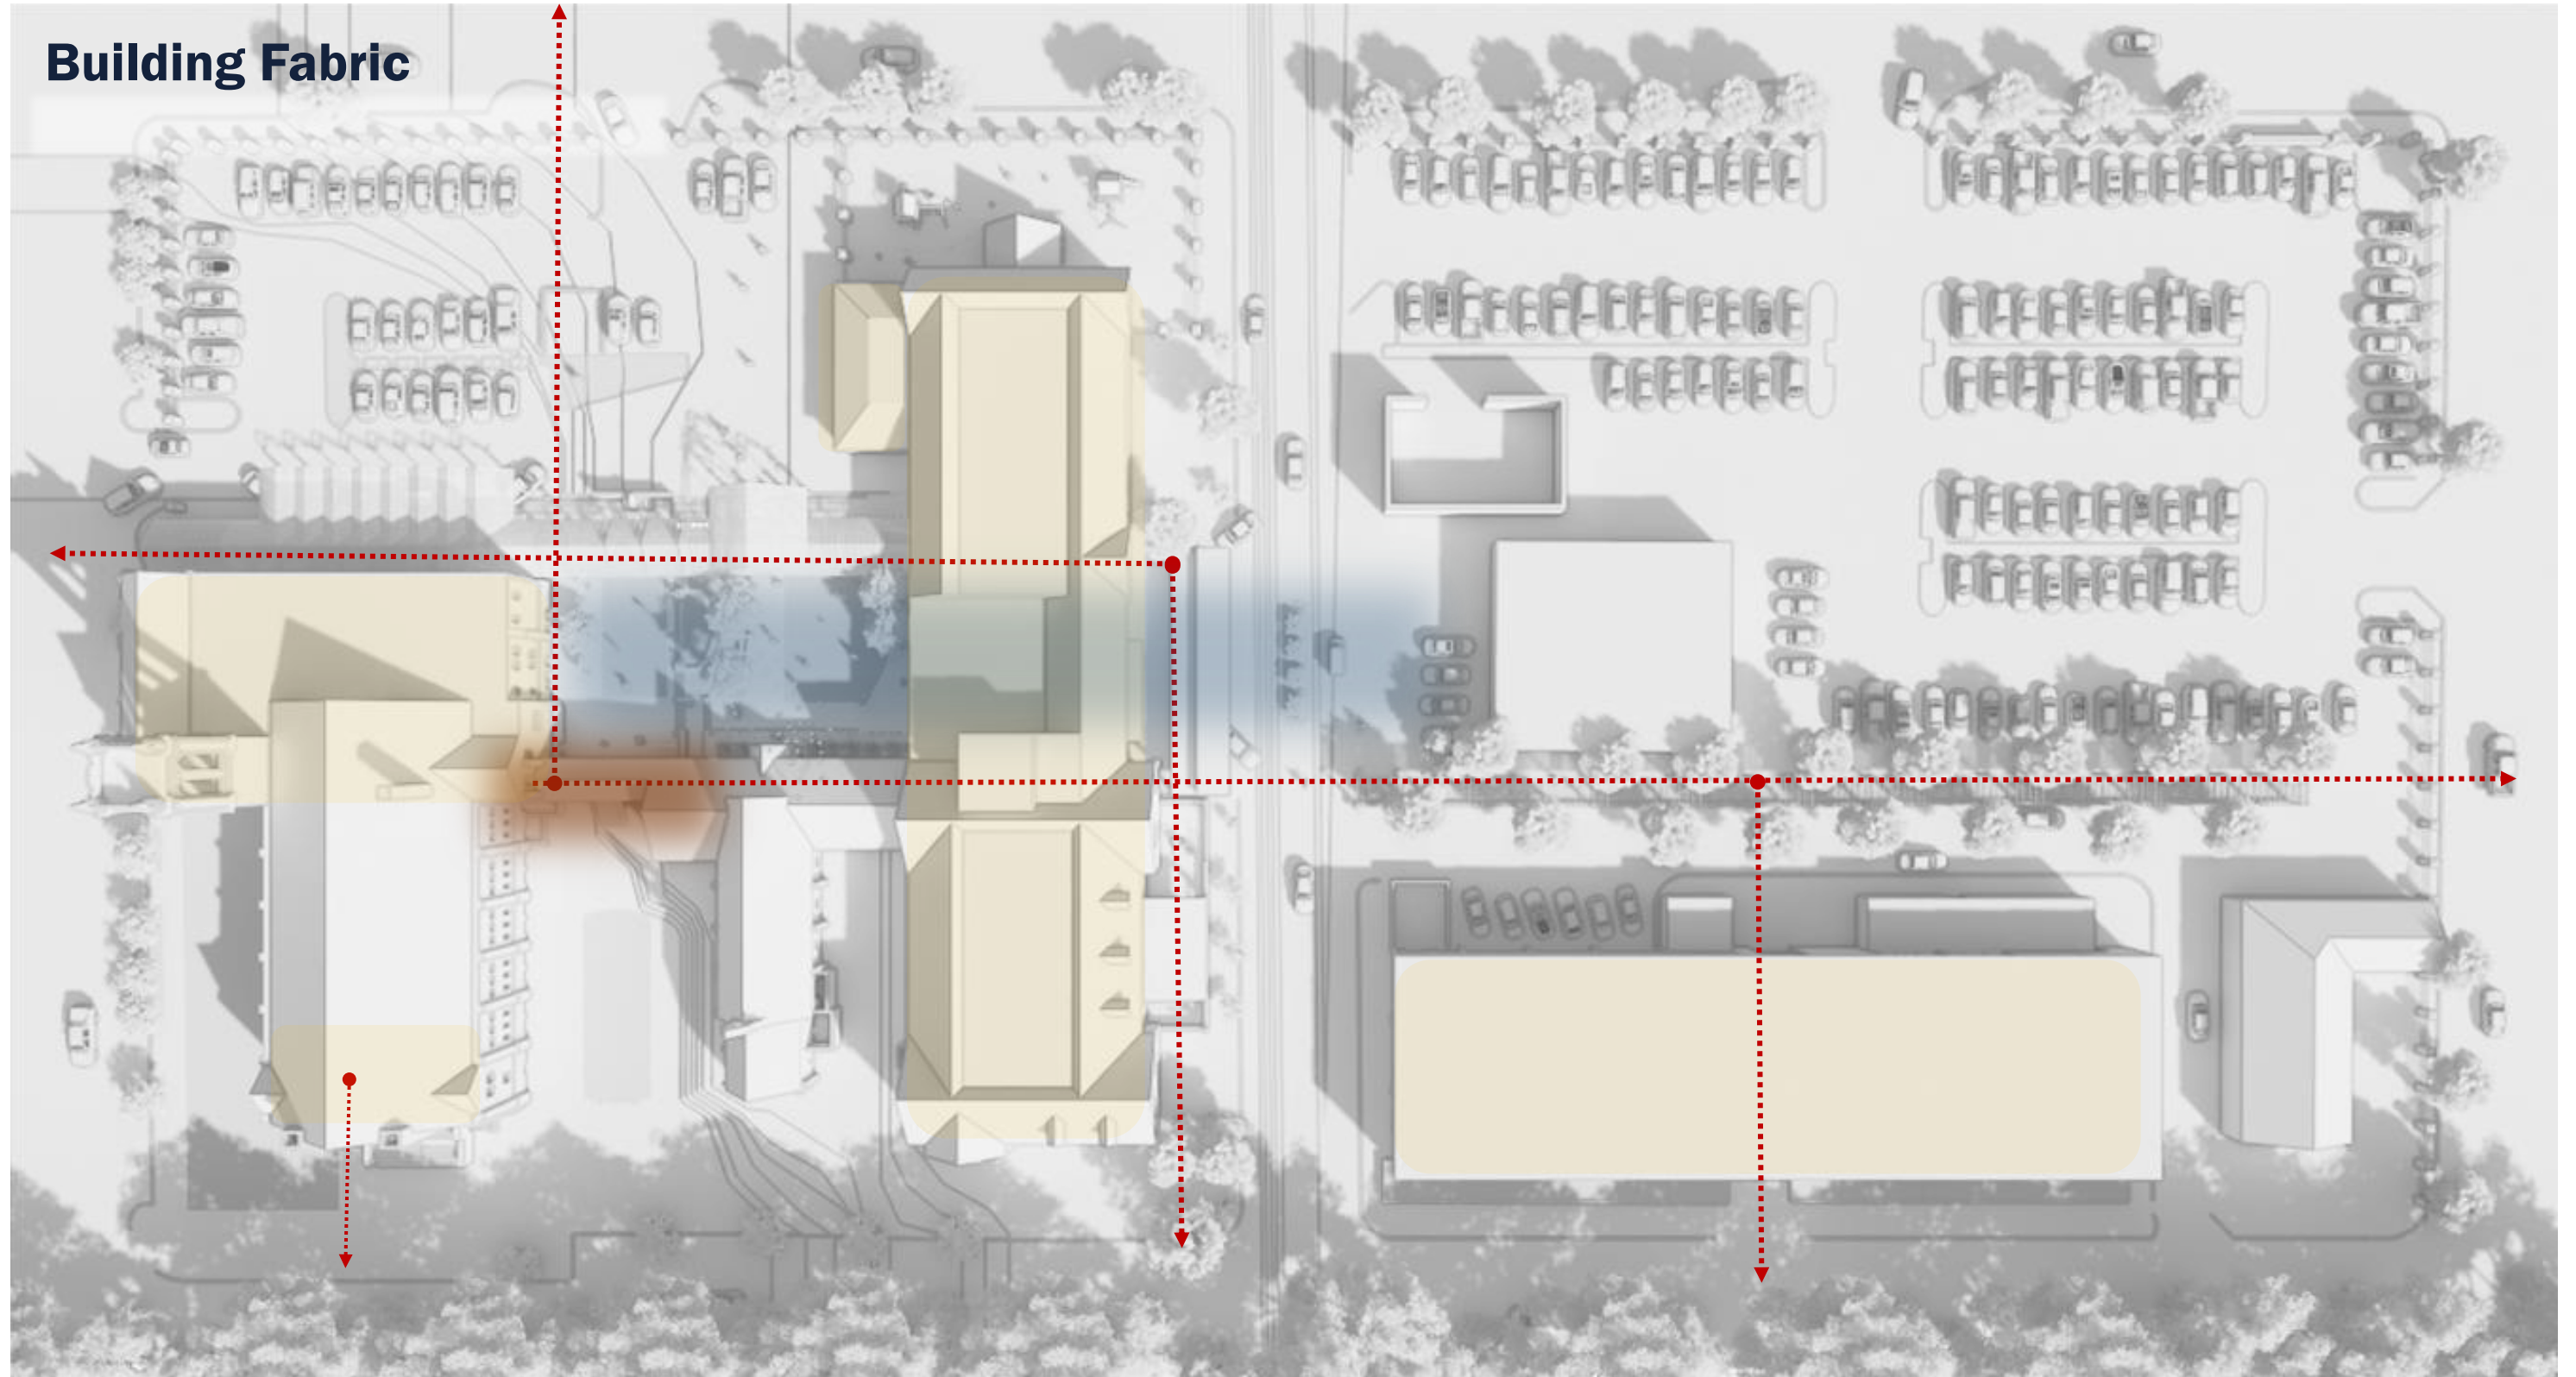
Building Fabric

Strategic renovations to existing campus buildings consolidate ministry functions and expand space available for respective ministry programming. Improved organization of campus allows for zoned campus security, operating efficiencies for respective campus buildings, safer MDO logistics, and improved discretion for Christian Counseling Center clients. Master plan objectives are achievable without the need to build new conditioned space.

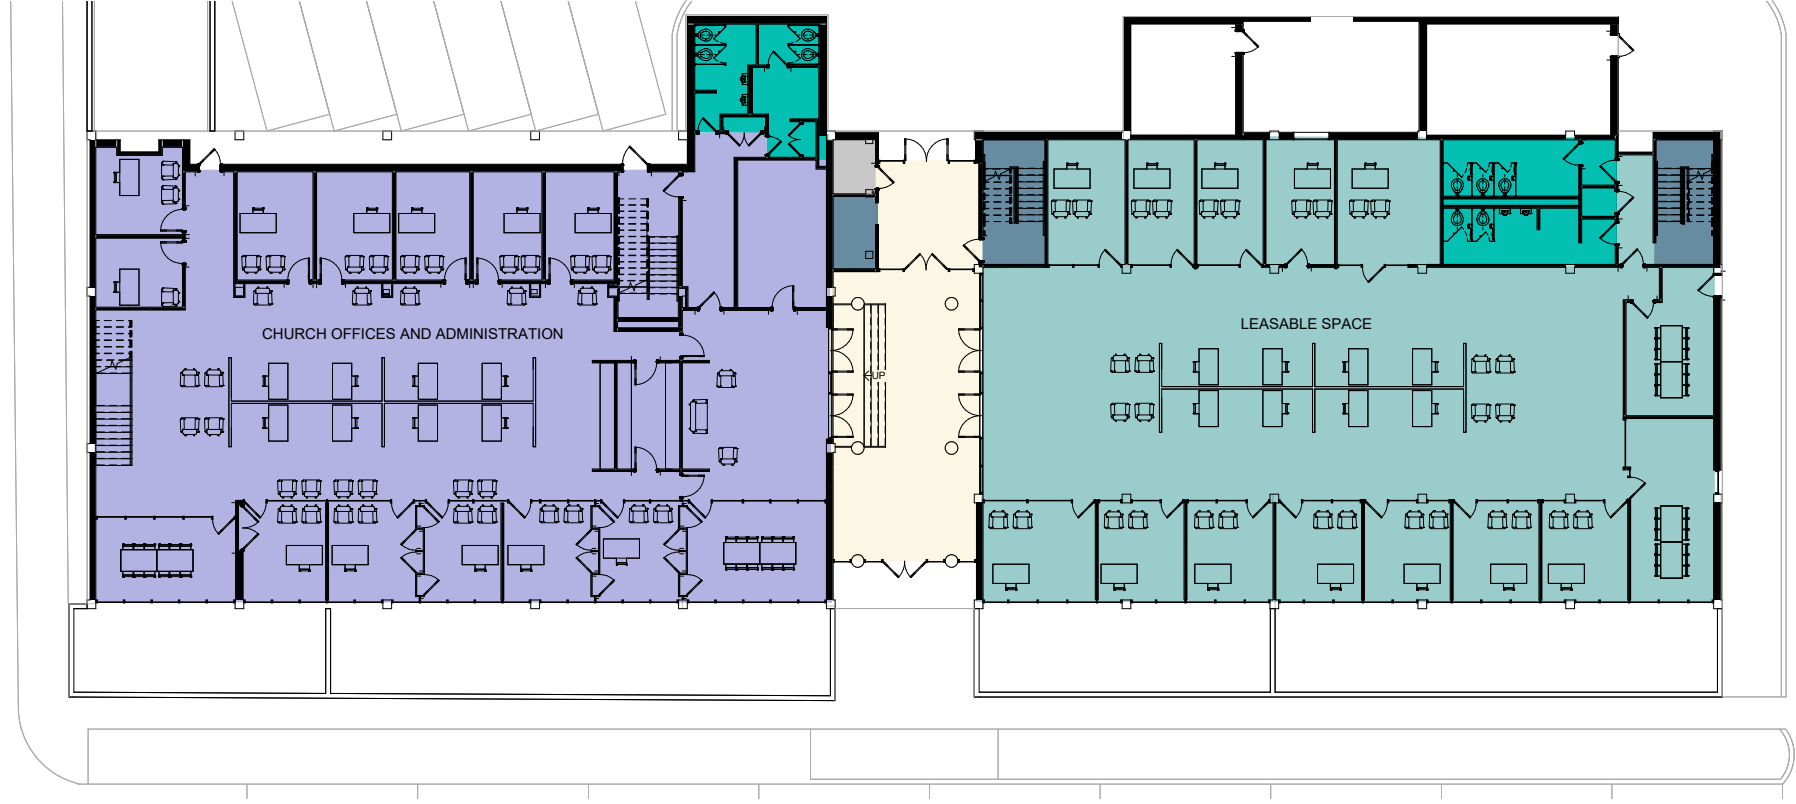
LEVEL 1

SPACE ALLOCATION		EXISTING QUANTITY/AREA	NEW QUANTITY/AREA	DELTA
 	Adult Education	8 classrooms / 4,189 sf	8 classrooms/4,730 sf	+13%
 	Youth Ministry	4 classrooms / 3,000 sf	5 classrooms / 3,870 sf	+29%
 	Children's Classrooms <i>first floor</i>	6 classrooms / 3,253 sf	6 classrooms / 4,645 sf	+43%
 	Preschool Ministry <i>second floor</i>	7 classrooms / 4,510 sf	Unchanged	N/C
 	Administration	28 offices / 9,000 sf	28 offices + support / 9, 150 sf	+2%
 	Community Spaces	3,635 sf	8,800 sf	+42%
 	Ministry Partners	2 offices / 1,000 sf	2 offices / 1,000 sf	N/C
 	Counseling Center	4,454 sf	12 - 15 offices / 5,100 sf	+15%
 	Lease Space	None	8,715 sf	+100%
 	Storage/Flex Space	3,903 sf	7,008 sf	+80%

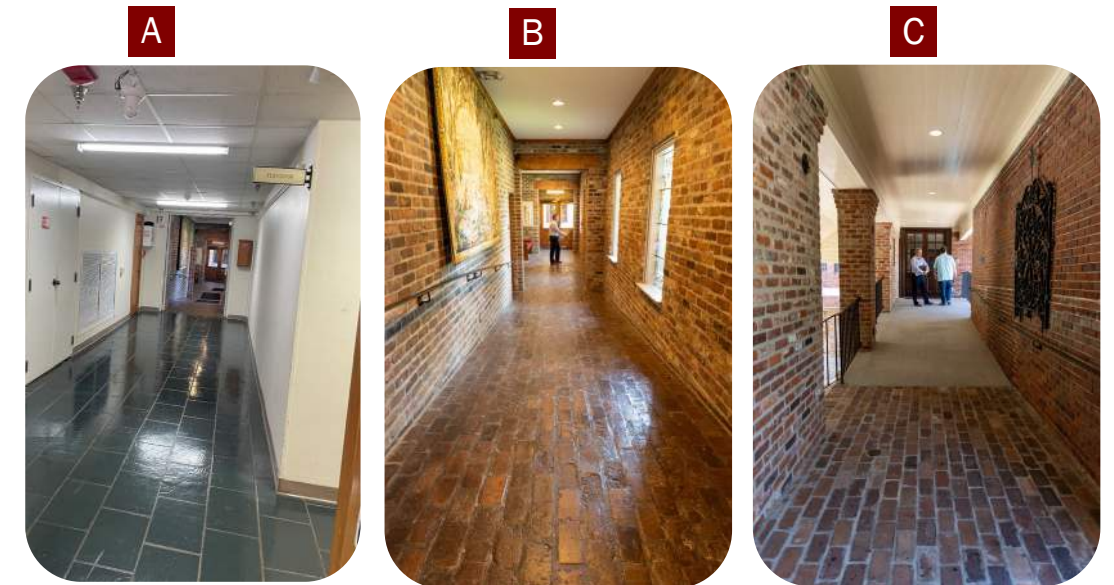
Campus Observations

E/W corridor is **campus circulation spine** & functions as **primary community gathering space**

Significant corridor **accessibility challenges** limit community gathering to **zones** with level floors

Community gathers in groups by zone:

Significant variation in visual experience by zone; Space limitations establish group size; Personal connection established at worship entry sequence

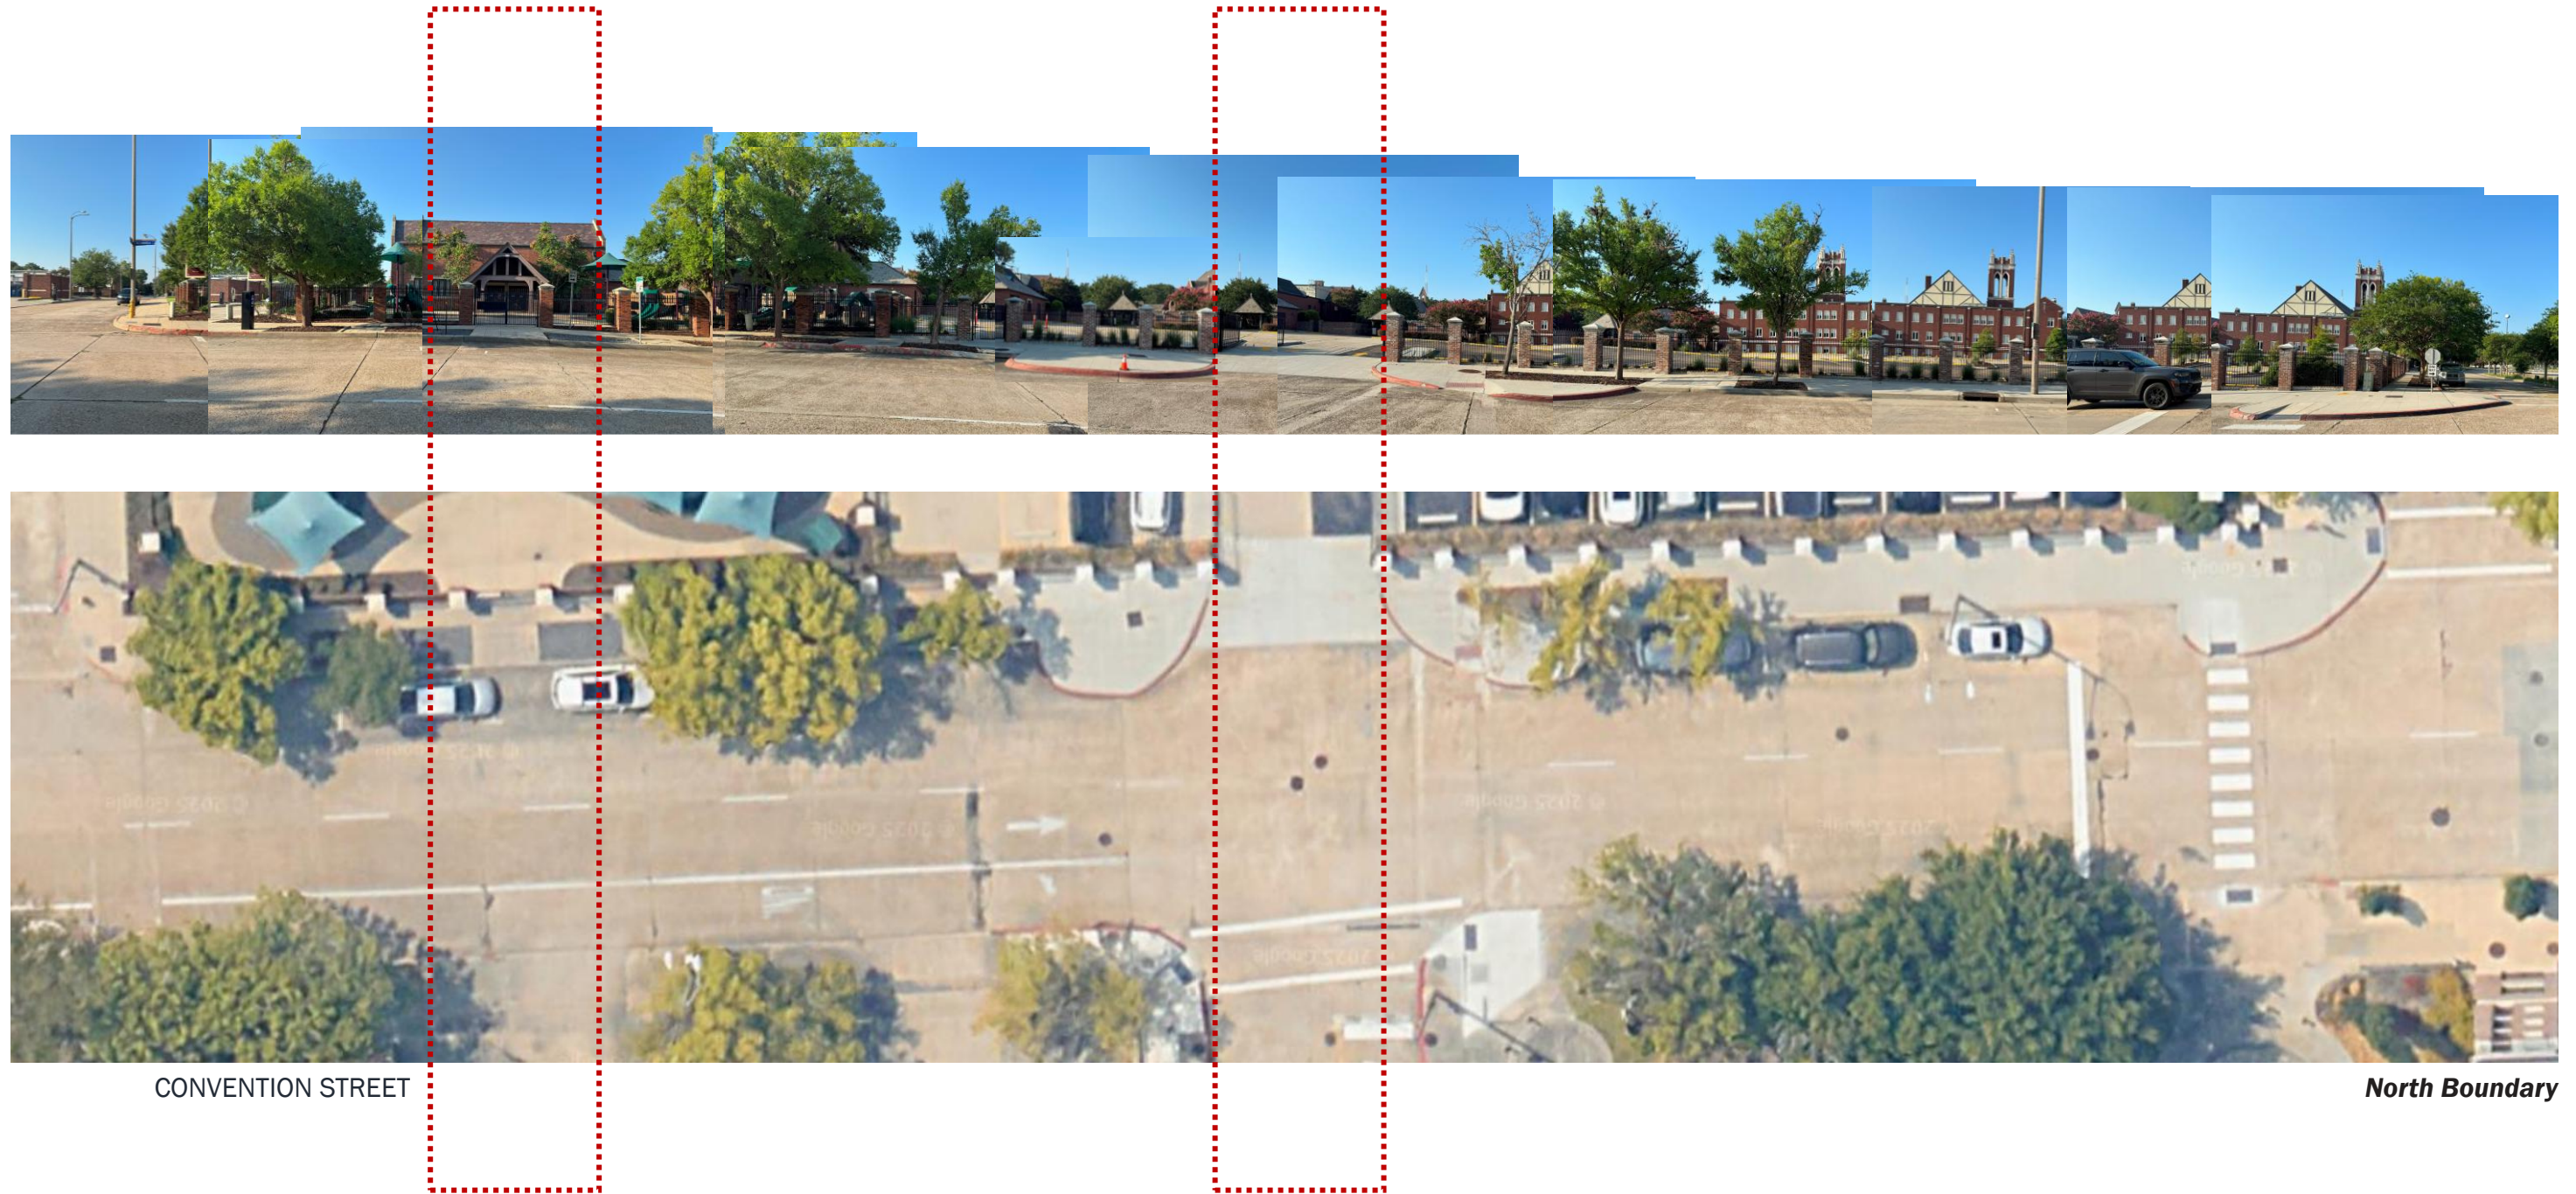
Observations 07.07.2025

Current patterns at the North boundary along Convention Street are vehicular focused with little pedestrian scale information.

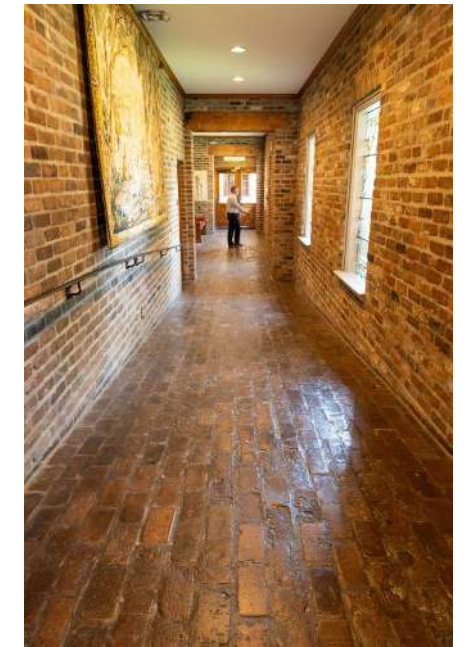
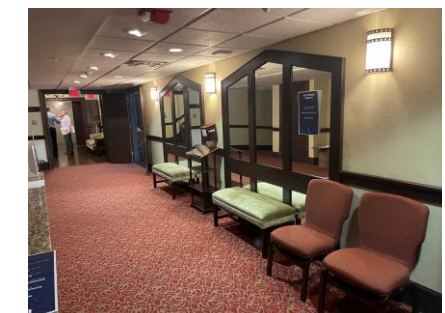
Accessibility 07.21.2025

Planning team's review of existing campus accessibility: Primary East-West corridor conditions are illustrated here. The corridor experience is fragmented by zone and existing ramps to and from the Dunham Chapel narthex. Ramps inhibit community use of the corridor, concentrating social interaction in constrained level-floor spaces as a natural consequence. Resulting campus circulation is often congested and confusing. Current "connect center" is hidden and difficult to locate.

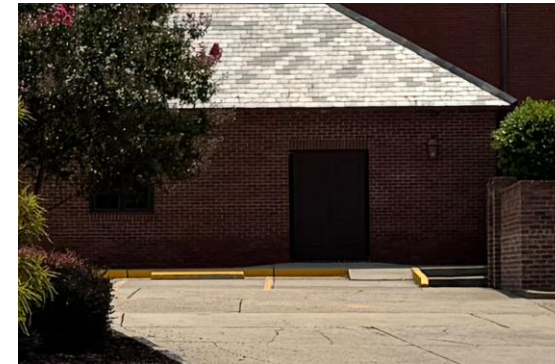
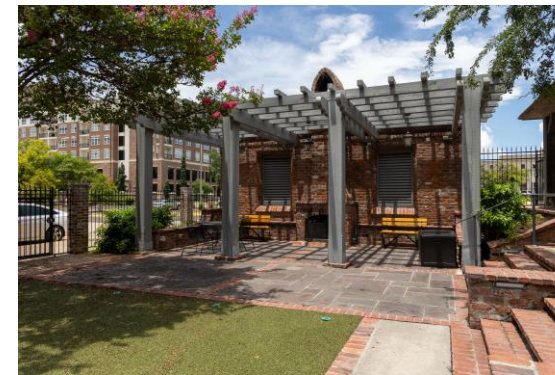
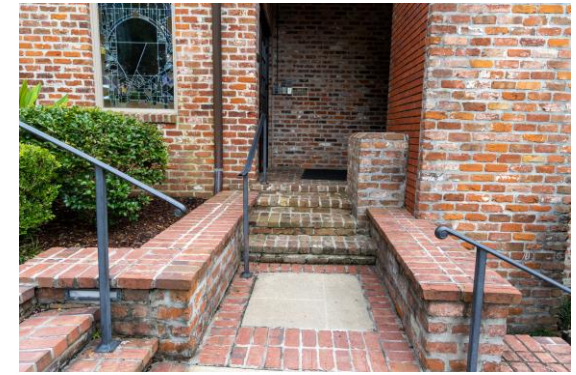
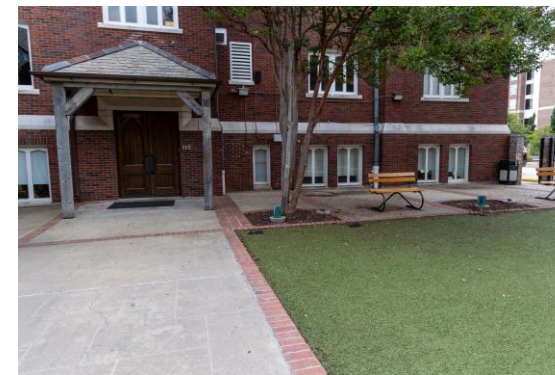
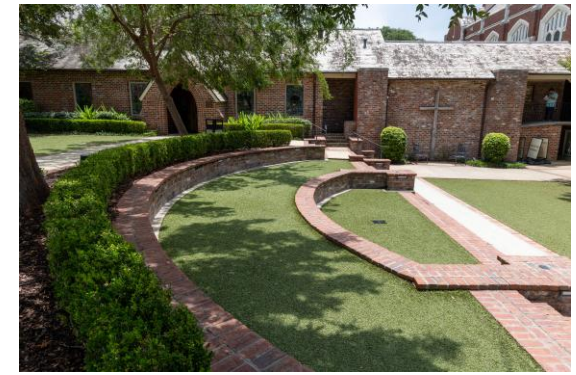
Accessibility 07.21.2025

Planning team's review of existing campus accessibility: Representative site conditions are illustrated here. Of special attention are conditions experienced by MDO families for drop-off and pick-up of children. Current conditions present safety risks and establish the bus barn as the first and last impression of the FPC church community.
