Comprehensive Master Plan

First Presbyterian Church *Baton Rouge, Louisiana*

COMPREHENSIVE PLAN

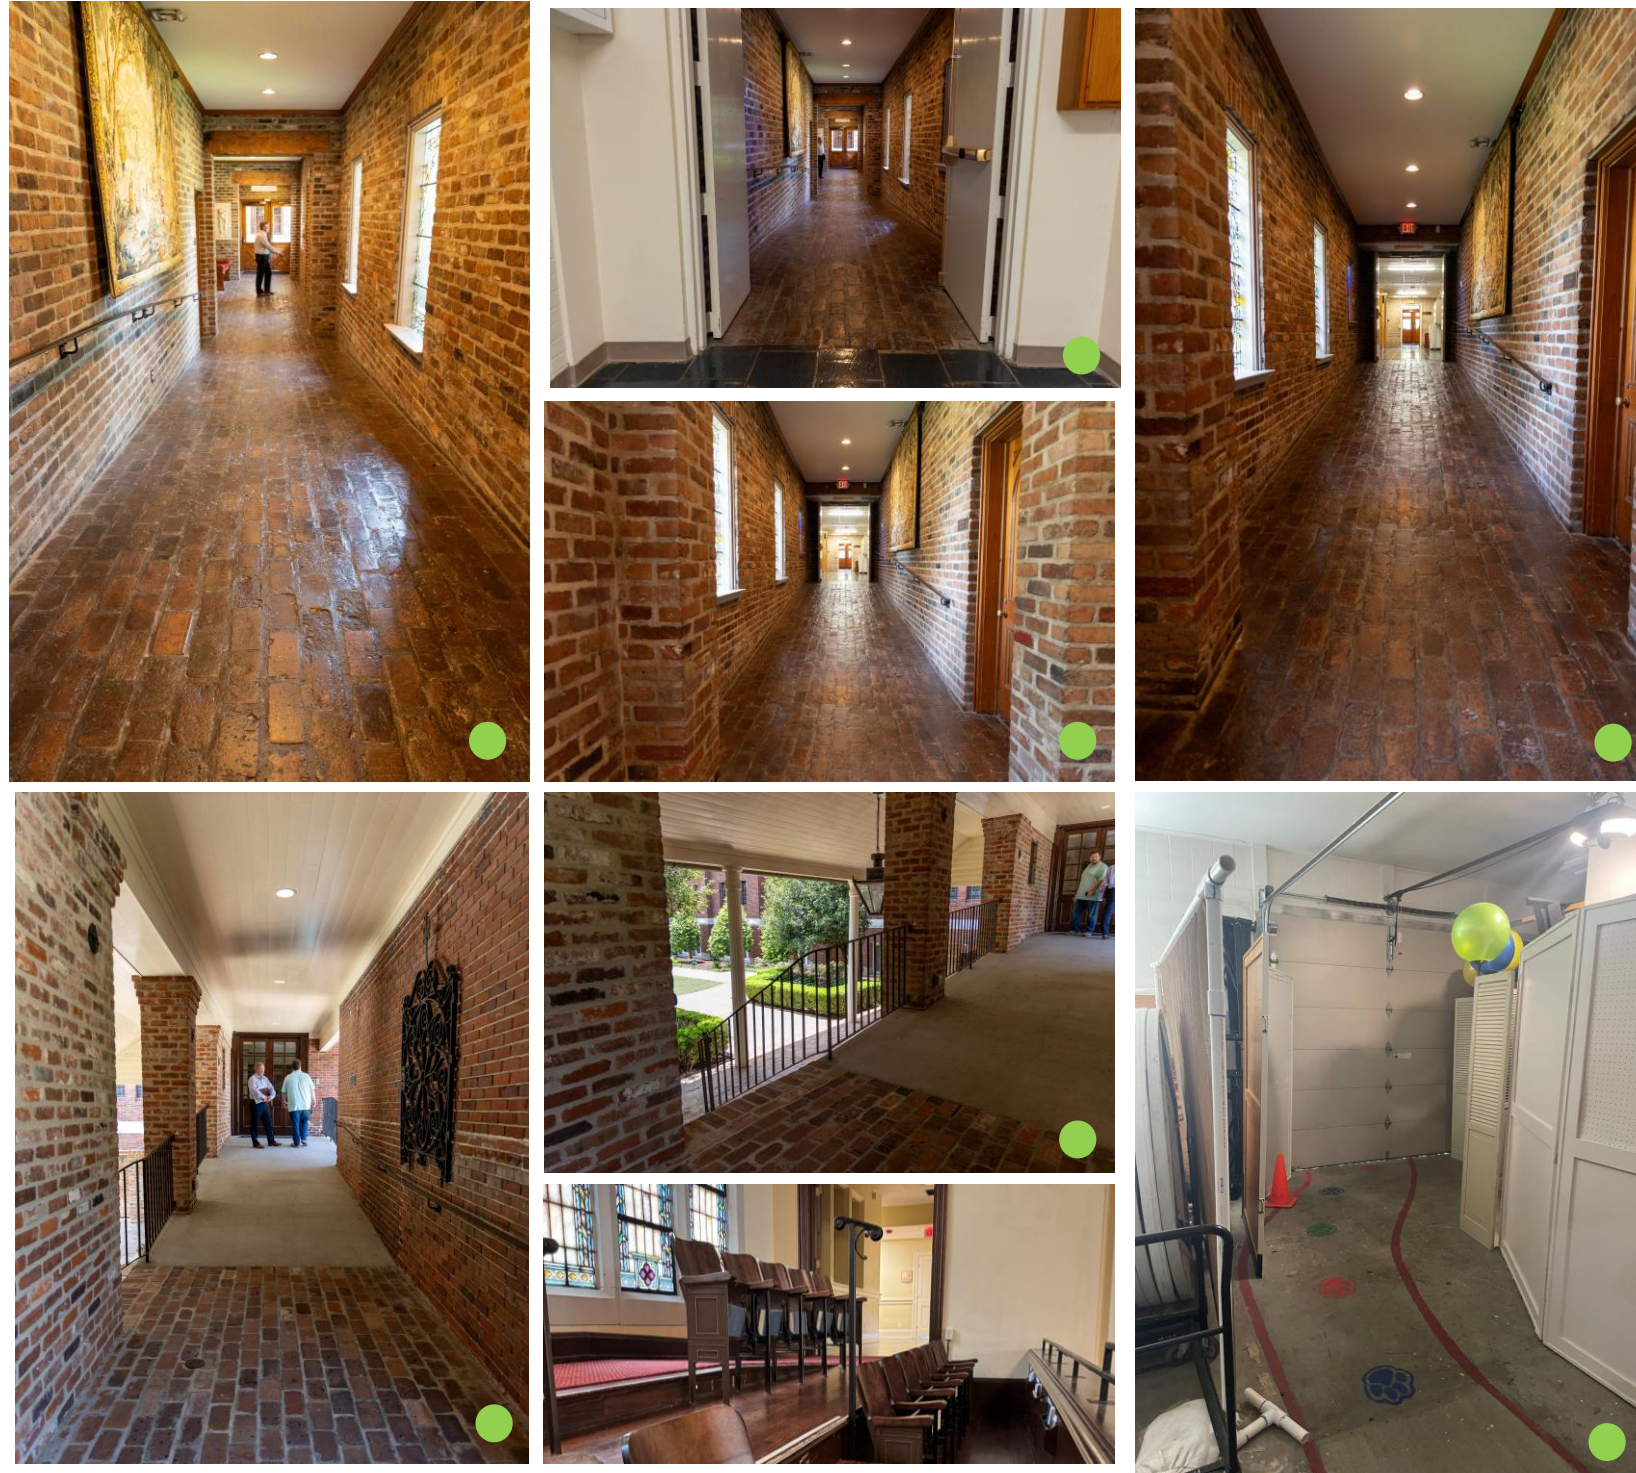
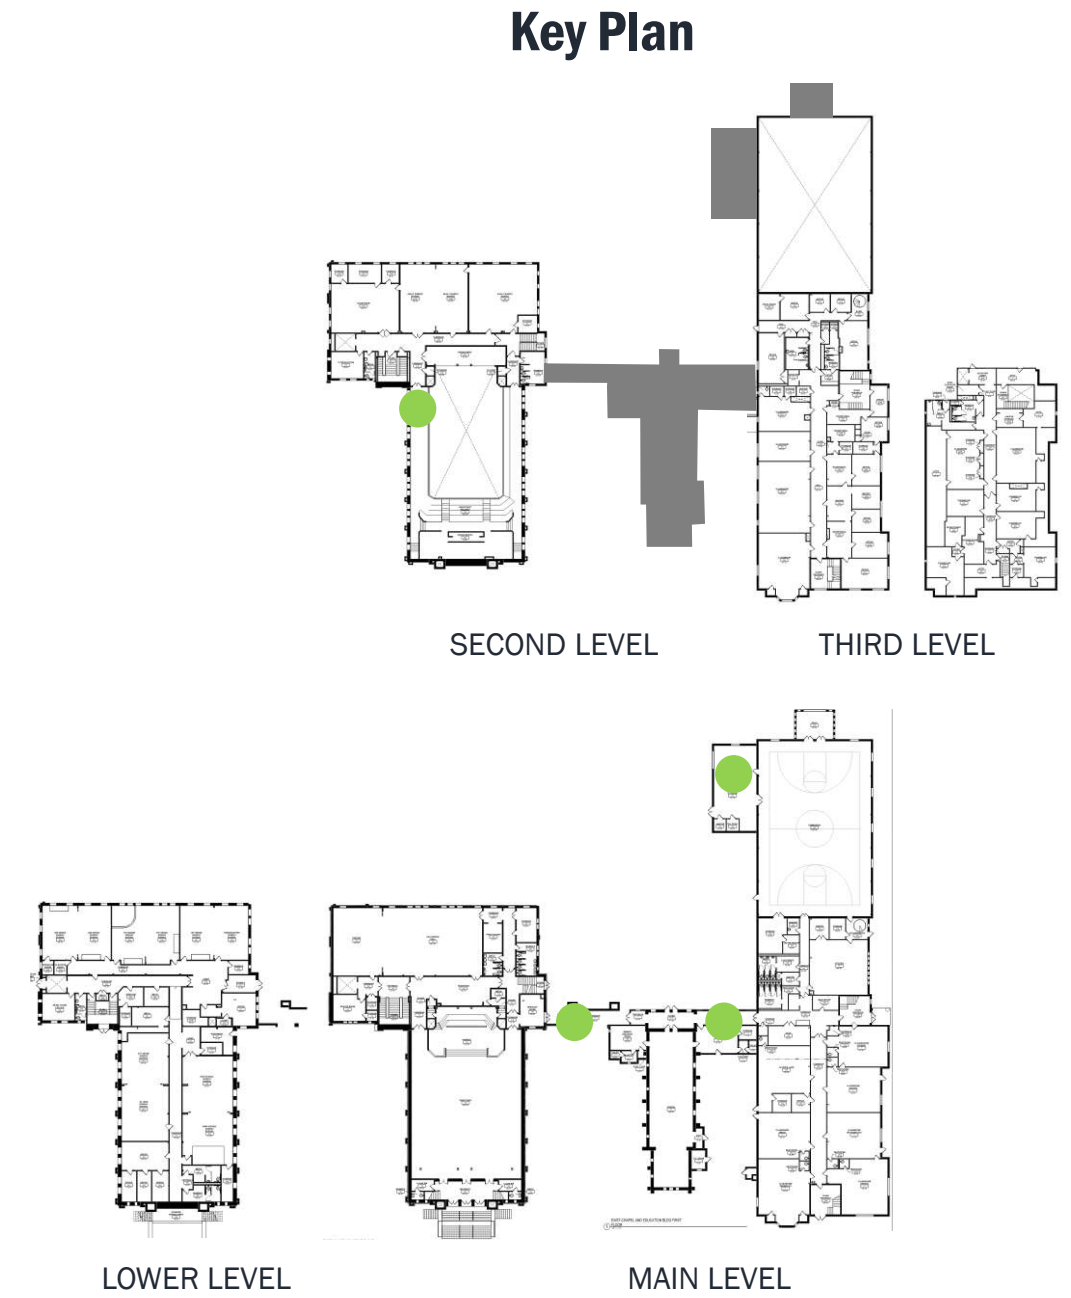
Accessibility 07.07.2025

Planning team's review of existing campus accessibility: Representative circulation conditions are represented here. Current conditions do not comply with latest accessibility standards and should be upgraded as master plan implementation projects are executed over time.

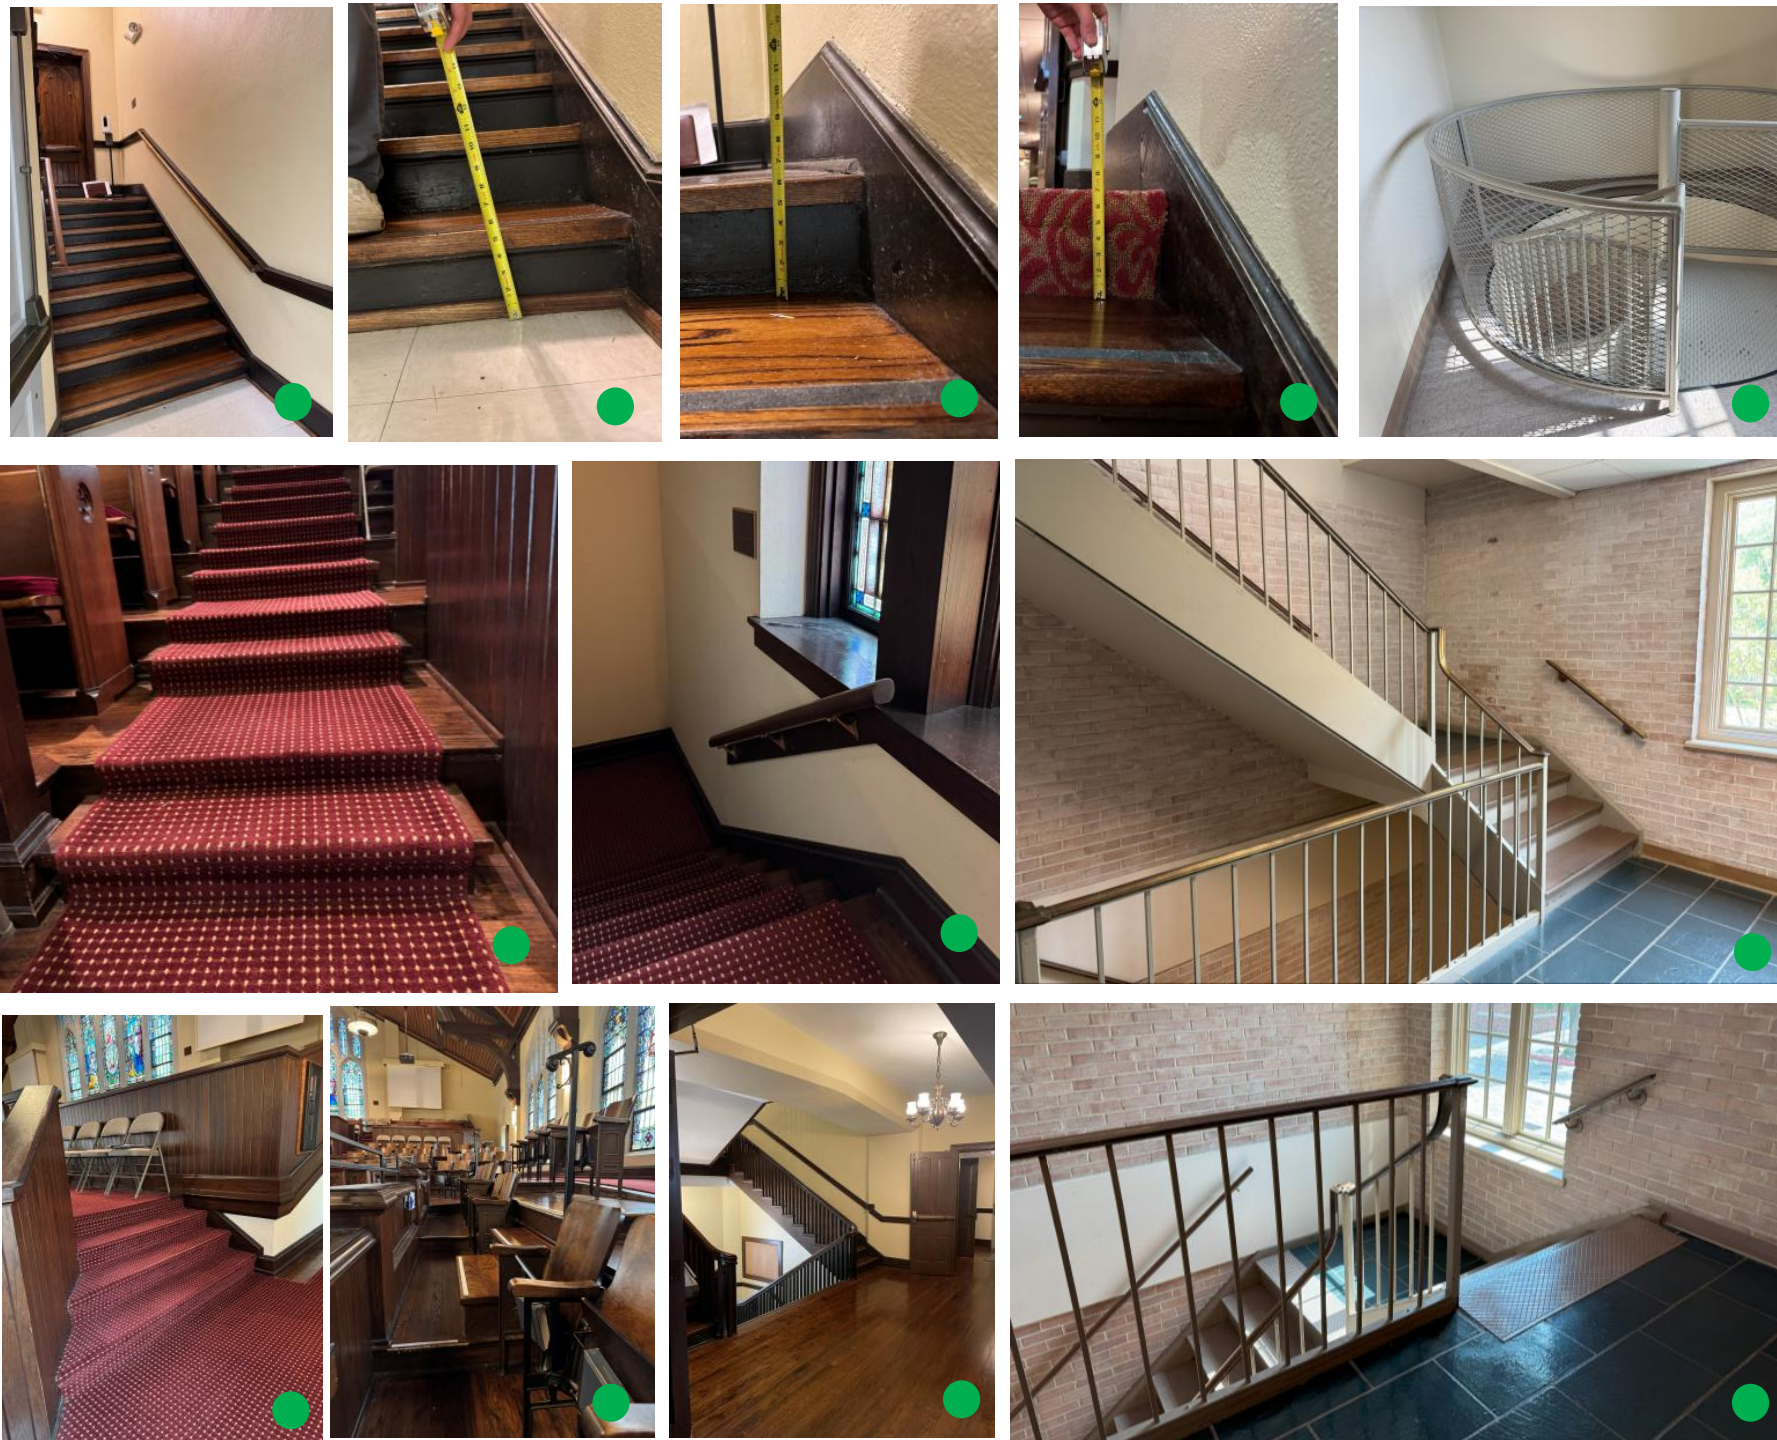
Accessibility 07.07.2025

Planning team's review of existing campus accessibility: Representative circulation conditions are represented here. Current conditions do not comply with latest accessibility standards and should be upgraded as master plan implementation projects are executed over time.

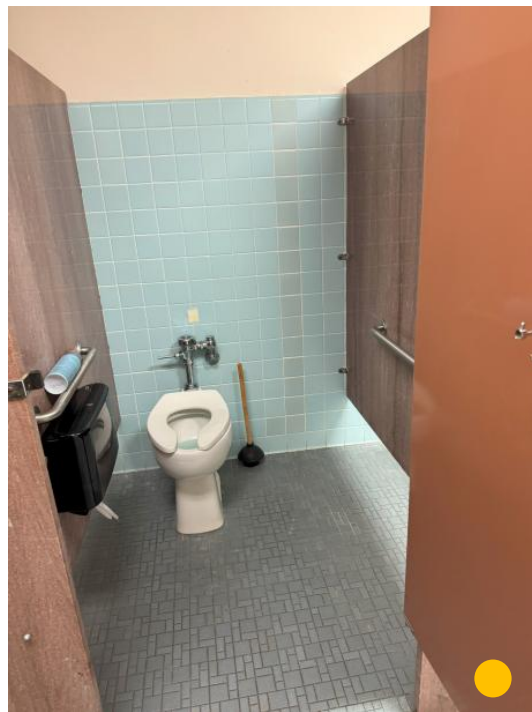
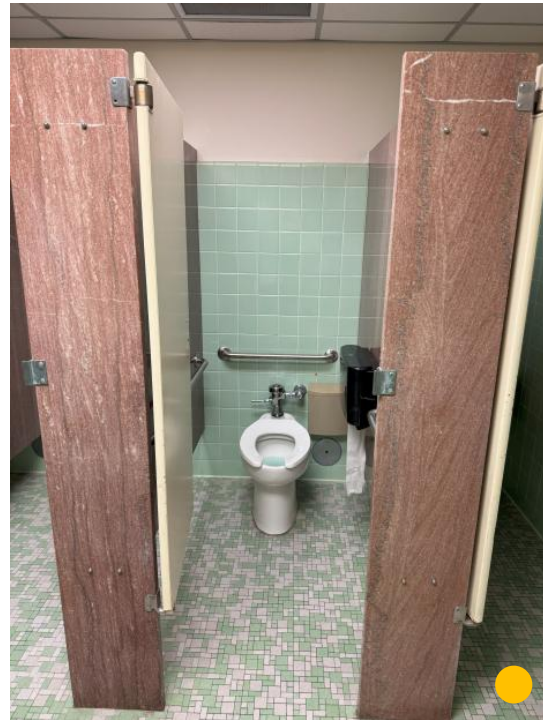
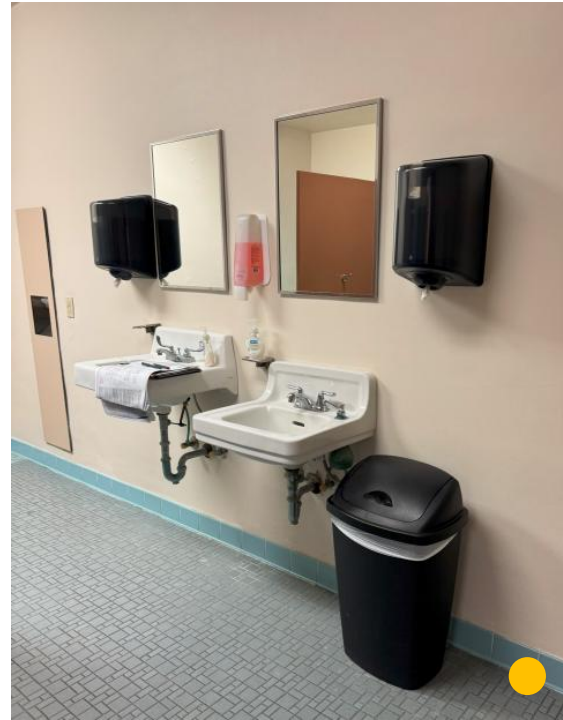
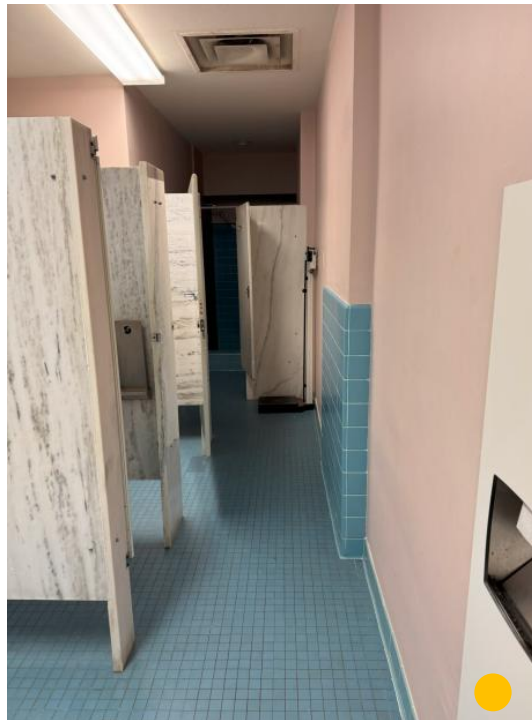
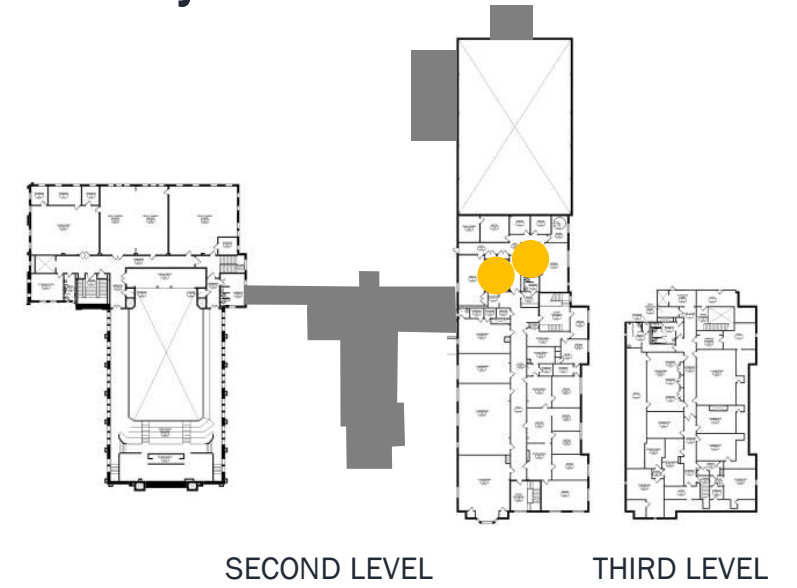
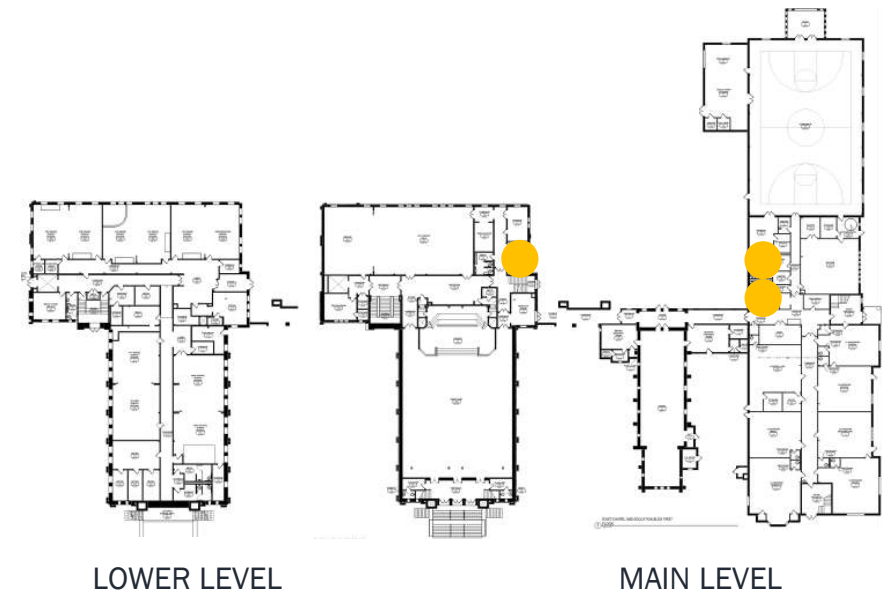
Accessibility 07.07.2025

Planning team's review of existing campus accessibility: Representative circulation conditions are represented here. Current conditions do not comply with latest accessibility standards and should be upgraded as master plan implementation projects are executed over time.

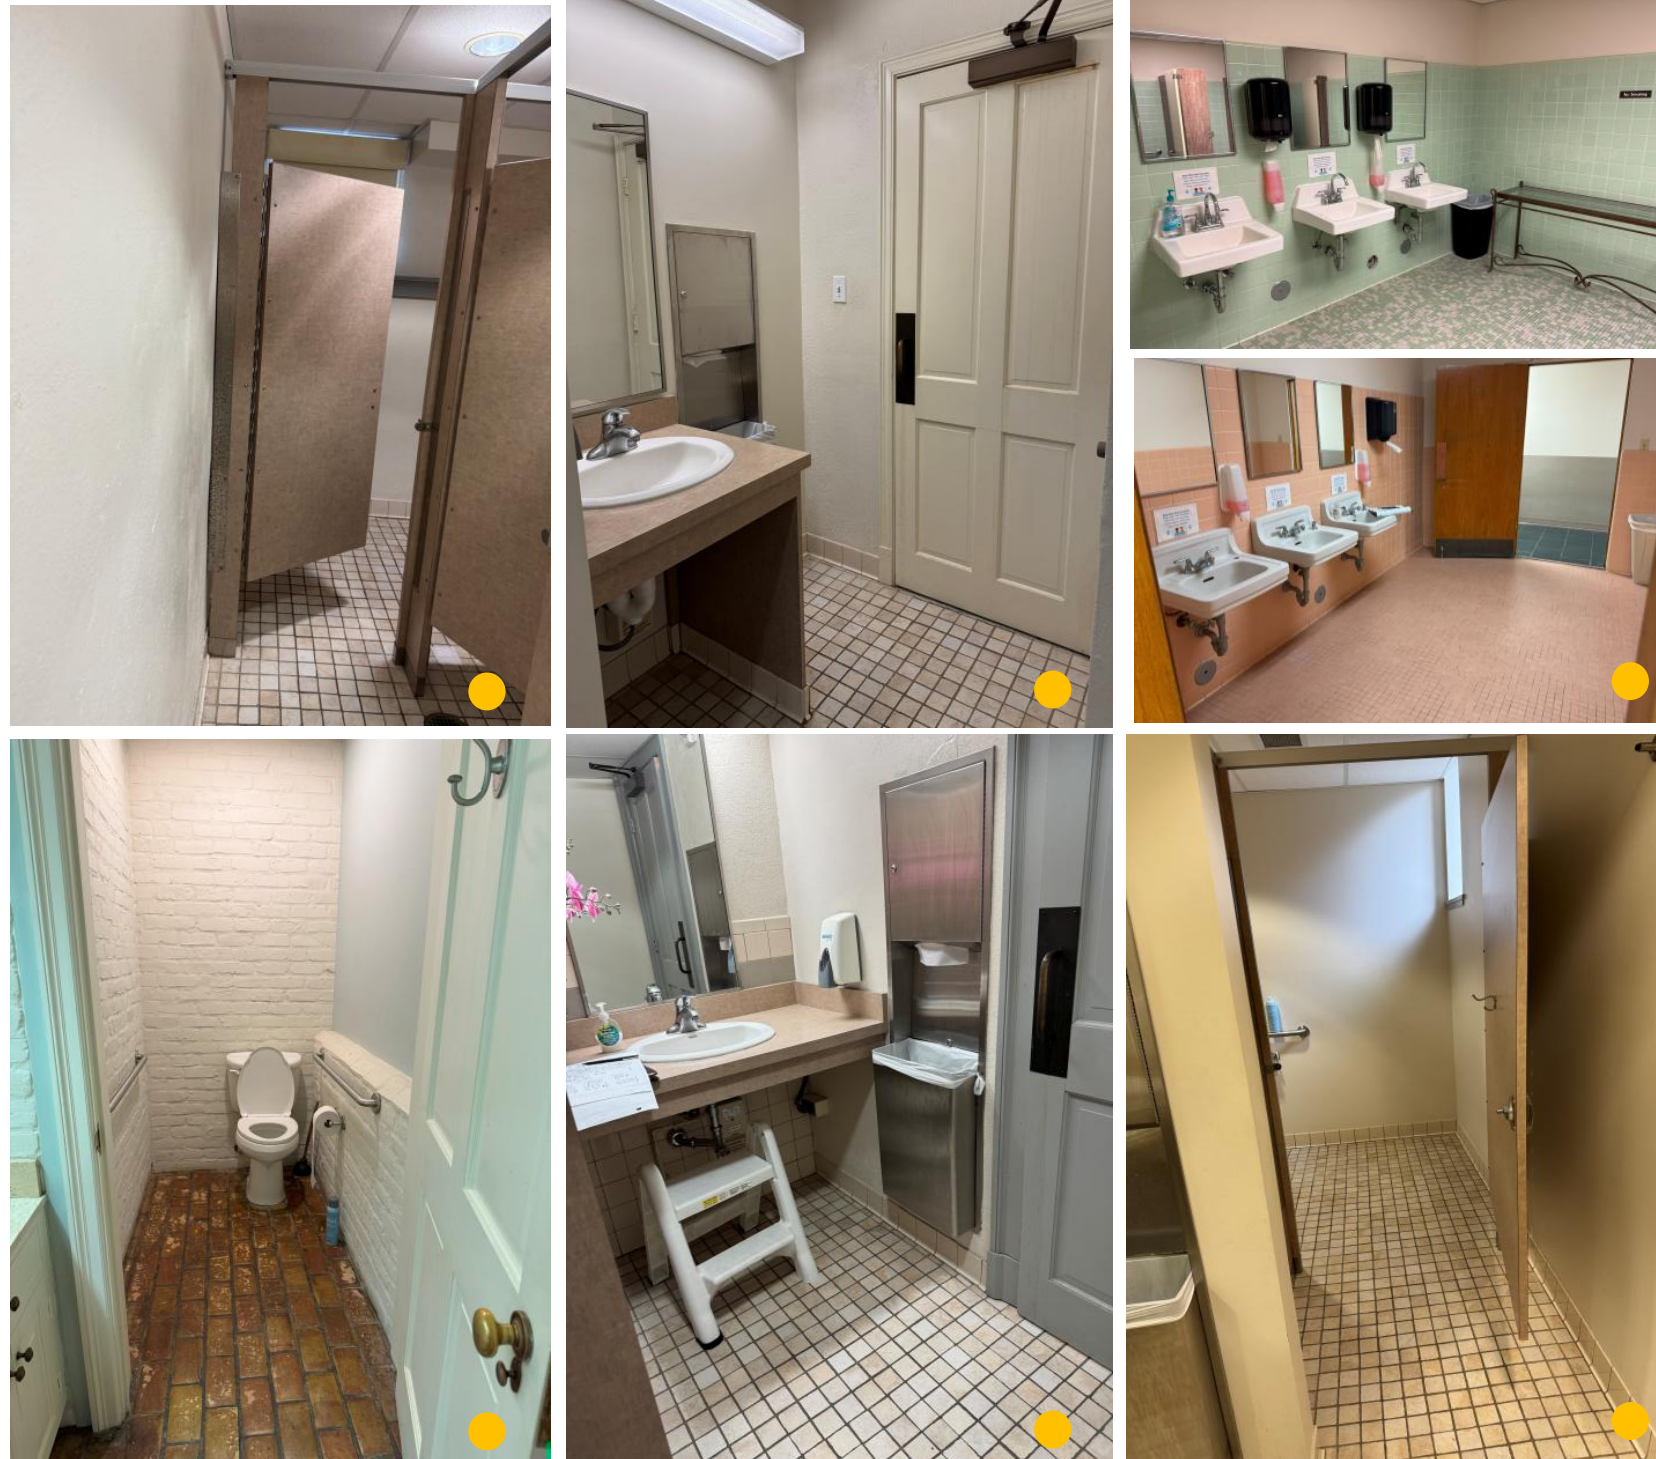
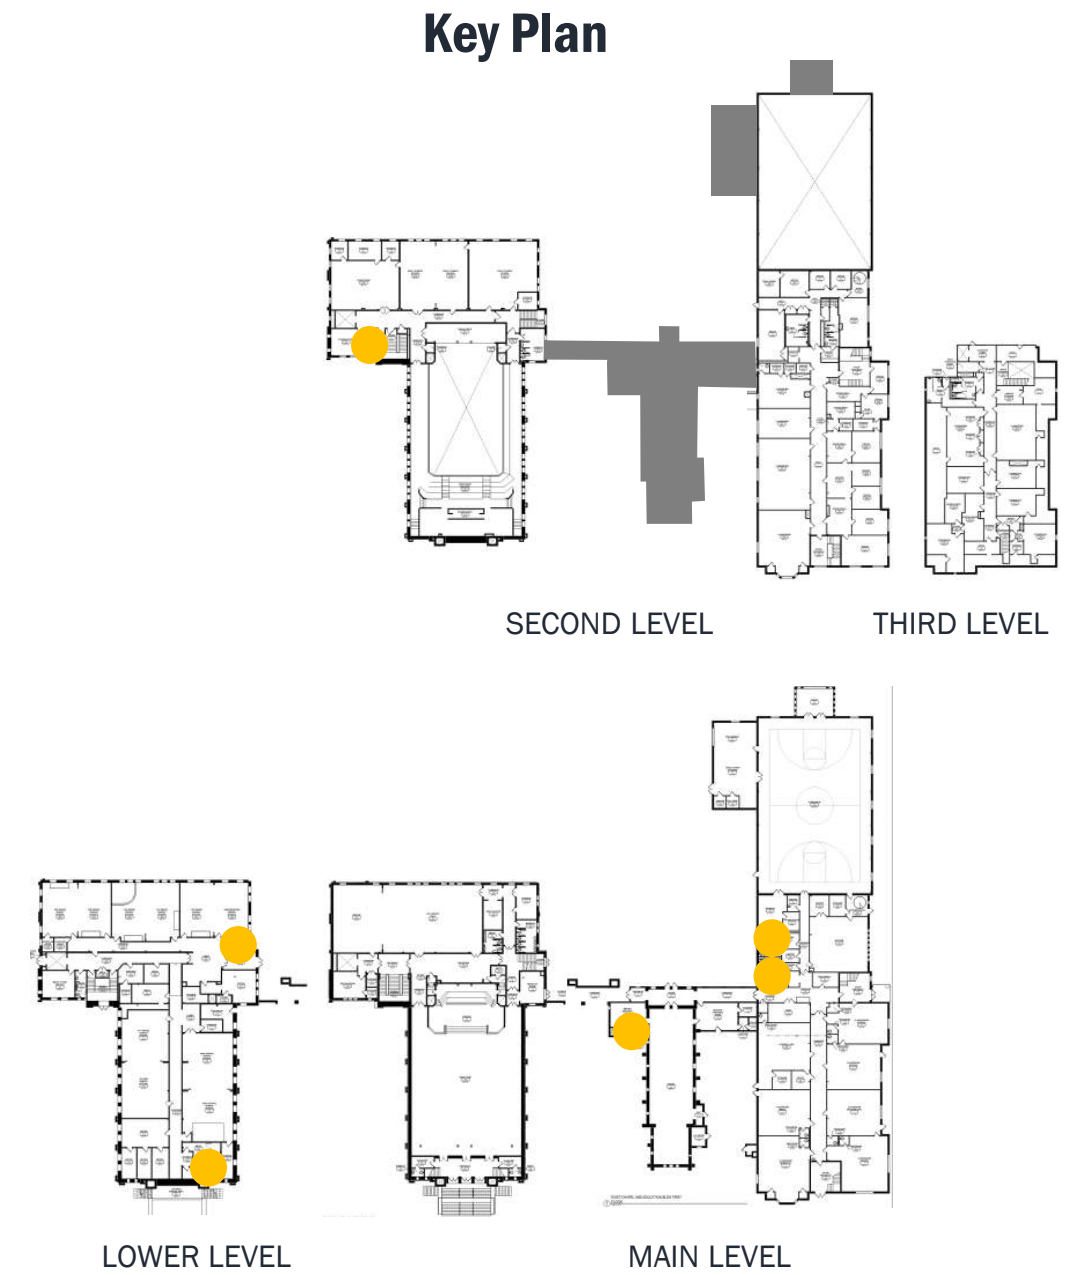
Accessibility 07.07.2025

Planning team's review of existing campus accessibility: Representative circulation conditions are represented here. Current conditions do not comply with latest accessibility standards and should be upgraded as master plan implementation projects are executed over time.

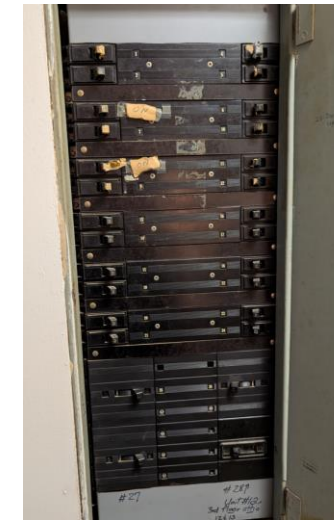
Electrical panels which were not replaced in the 2010 renovation are in fair condition when age is considered. While these panels do not appear to be of immediate hazard or concern, it is certain that replacement circuit breakers and other components are not commercially available, and replacement parts would only be available in refurbished condition from secondary markets. An example photograph of one of these panels installed on an upper level of the classroom building follows.
